TITLE	Lens Thermal Cold Test
DOCUMENT TYPE	REPORT
DOC No.	AMST/CTVL/1/A
ISSUE No.	1
DATE	19/07/06

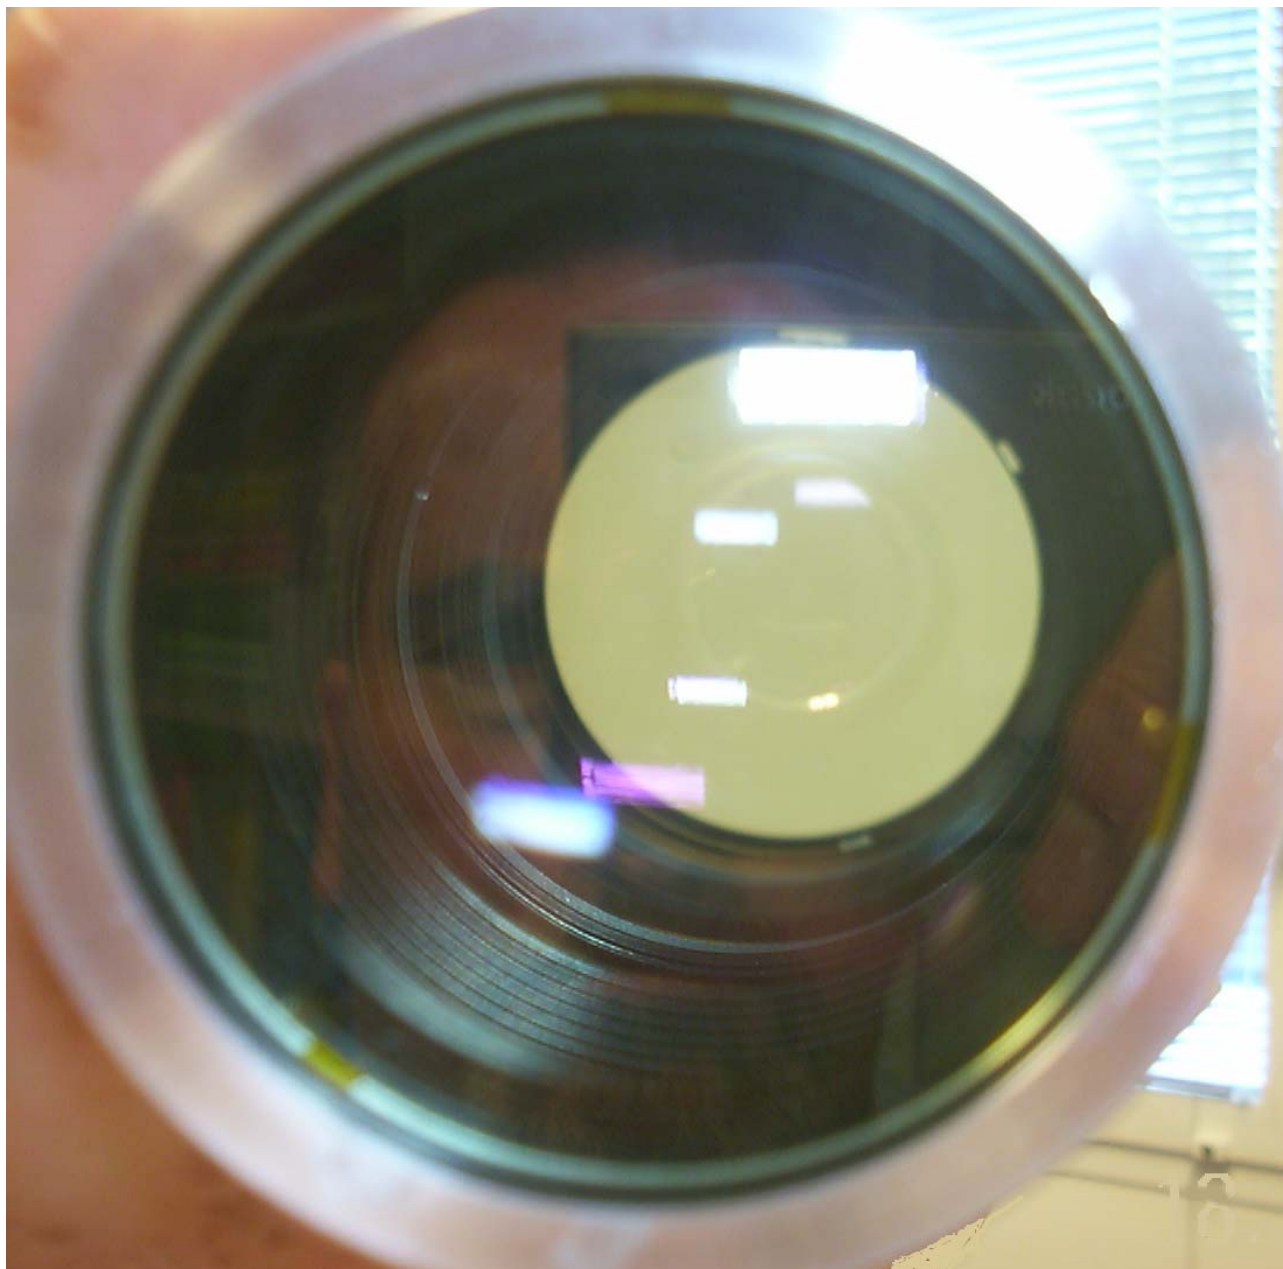
After the test an accurate visual inspection was performed on lens and filters. No damage was noticed. In the next two pictures taken after the test, the lens assembly is shown.

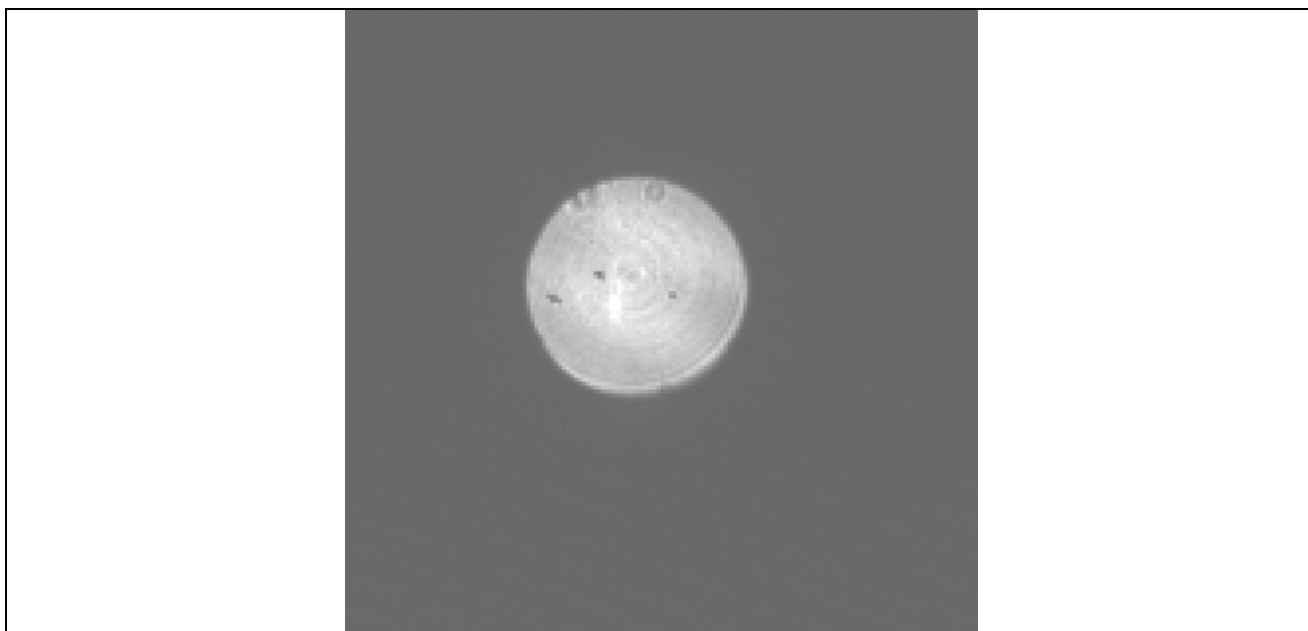
A spot generated by a laser and the beam expander was acquired. In the following figures the spot acquired image and a 3D graph of the spot are given.

Image of the spot

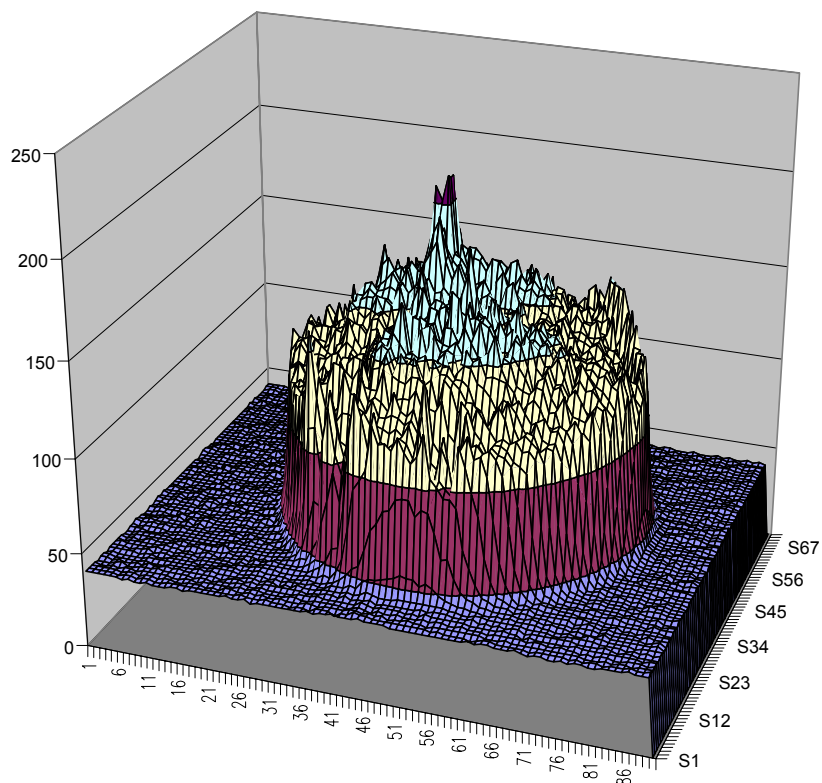
3D visualization of the spot
